Periodic Inspection of St. Paul Harbor Breakwater, Alaska

Robert R. Bottin, Jr., and Alan C. Jeffries

February 2001

Final report

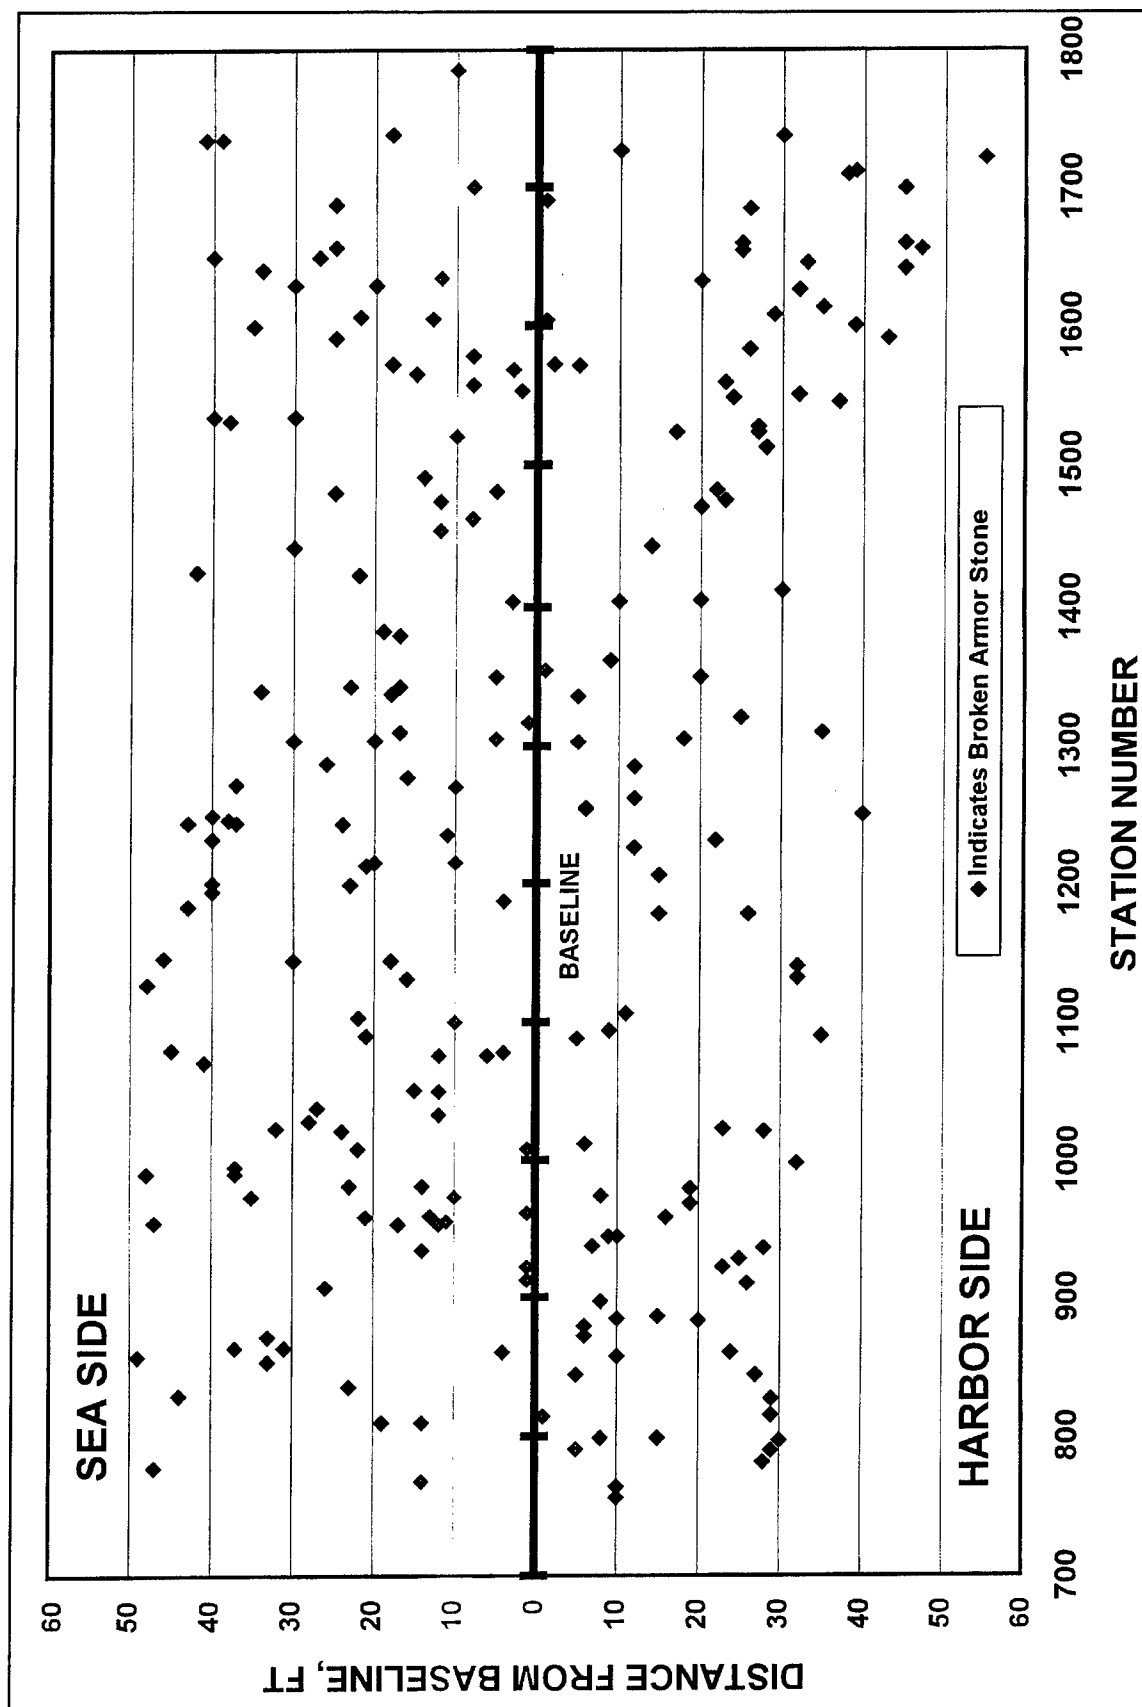
Figure 16. Distribution of broken armor stones along breakwater trunk relative to station number (To convert feet to meters, multiply by 0.3048)

The survey revealed a total of 221 broken or cracked armor stones above the waterline. A total of 219 broken stones was noted on the trunk of the breakwater with only two observed around the head of the structure. Of the 219 stones along the trunk, 55 were located along the breakwater crest, 95 on the sea side slope, and 69 on the harbor side slope. The distribution of broken armor stones along the breakwater trunk as a function of station number and offset from the baseline is shown in Figure 16. Broken stones were, in general, relatively evenly distributed along the length of the structure. The survey indicated that 54 percent of the broken stones were located on the shoreward half of the breakwater extension and 46 percent were on the outer half. About 25 percent of the observed stones were along the crest, 43 percent on the seaward slope, and 32 percent on the harbor side slope. Of the broken stones located on the breakwater slopes, the survey revealed that 44 percent of the broken stones were located on the upper half of the slopes (28 percent on the sea side and 16 percent on the harbor side; and 56 percent were on the lower half of the structure slopes (30 percent on the sea side and 26 percent on the harbor side). The distribution of broken/cracked armor units relative to offset from the baseline is shown in Figure 17.
